# Autoclave Repair using Belzona Superwrap II

ID: 8881

**Industry:** Chemical & Petrochemical  
**Application:** VPF-Valves, Pipes and Fittings  
**Substrate:** Carbon steel  
**Products:** Belzona 1111 (Super-Metal),  
Belzona 1983 (Superwrap II Resin),  
Belzona 9381,  
Belzona 9382,

**Customer Location:** Netherlands  
**Application Date:** October 2022

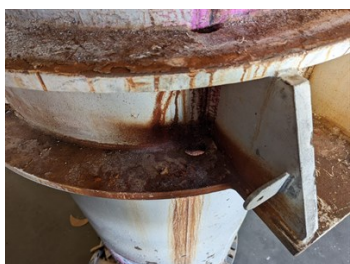
Leaks on the weld seam of the water-cooled jacket of this process vessel.

Initial condition

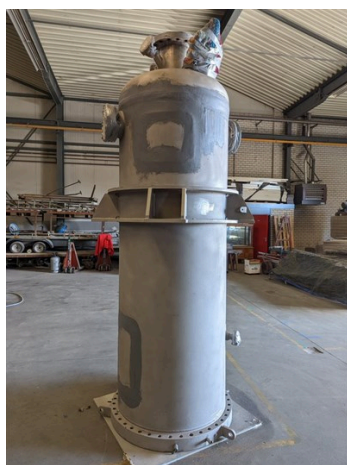
Plate bonding applied

Application carried out in accordance with a modified version of Belzona Know-How System Leaflet VPF-11. After blasting, the weak spots in the mantle are filled with the Belzona 1111 metal paste. Then the wrapping repair was carried out in at least 3 layers. The resin selected for this application is the Belzona 1983, because of the temperatures and the longer processing time. Belzona SuperWrap II is a composite repair that strengthens weaker metal structures on pipes and process vessels, mainly when applied on high-pressure systems.

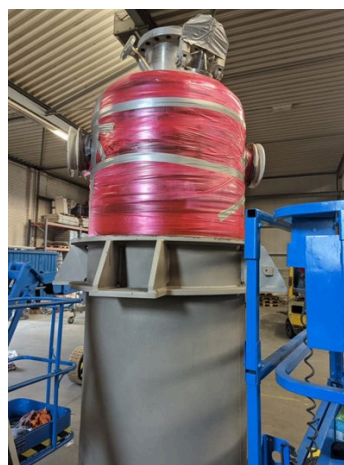
Application of Belzona  
SuperWrap II

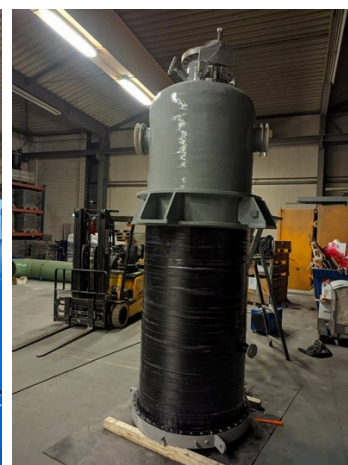
Complete application

A composite repair was carried out on a process vessel in the chemical industry using Belzona SuperWrap II. In order to prevent further leaks and to extend the life of the process vessel.
