# BELZONA REPAIRS NEW HEAVY EQUIPMENT TIRE

ID: 889

Application: SHM-Solids Handling Machinery

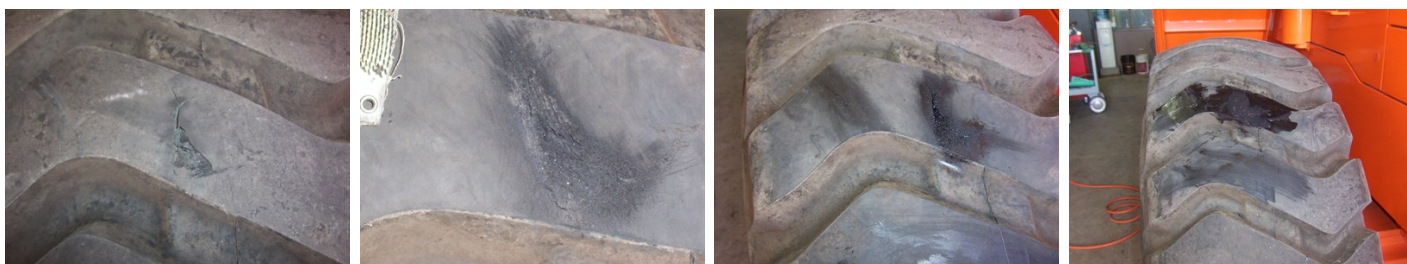
When the transport unloaded this brand new loader, the tire was damaged.

- \* Damaged portion of the tire ,
- \* Roughened surface ,
- \* Surface conditioned ,
- \* Tire rebuilt with Belzona® 2311 ,

The application was carried out in accordance with Belzona Know-How System Leaflet SHM-1. The surface was prepared with a roughing brush and conditioned with Belzona® 2911 (QD Conditioner). The gouges in the rubber tire cover were rebuilt with Belzona® 2311.
