Wastewater Pump Impeller

ID: 8912

Industry: Water / Wastewater
Application: CEP-Centrifugal Pumps
Substrate: Carbon steel
Products: Belzona 1111 Supermetal
Belzona 1321 S-Metal

Customer Location: Columbia, SC
Application Date: 12/17/22

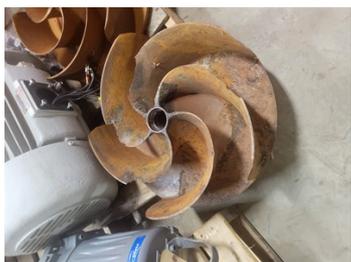
Pump Impeller was pitted and damaged, and missing chunks out of a few of the veins, and they were wore down on the ends. We needed to build up the veins and pitted areas, and then coat to protect the impeller from further damage in the future.

Damaged Impeller

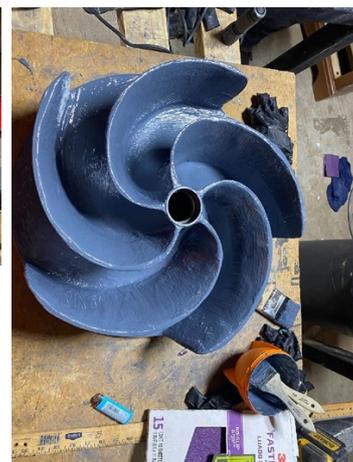
Impeller rebuilt with expanded metal, Belzona 1111 Supermetal, and coated with Belzona 1321 S-Metal.

We sandblasted the impeller to a 3 mil profile. Built up the damaged areas with expanded metal and Supermetal. Then we applied two coats Belzona 1321 S-Metal.
