Wastewater Pump Impeller

ID: 8912

Industry: Water / Wastewater
Application: CEP-Centrifugal Pumps
Substrate: Carbon steel
Products: Belzona 1111 Supermetal
Belzona 1321 S-Metal

Customer Location: Columbia, SC
Application Date: 12/17/22

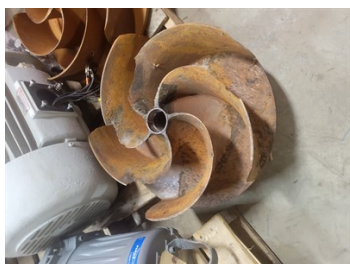
Pump Impeller was pitted and damaged, and missing chunks out of a few of the veins, and they were wore down on the ends. We needed to build up the veins and pitted areas, and then coat to protect the impeller from further damage in the future.

Damaged Impeller

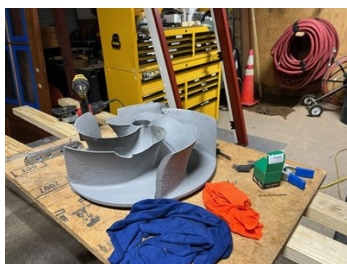
Impeller after being blasted

We sandblasted the impeller to a 3 mil profile. Built up the damaged areas with expanded metal and Supermetal. Then we applied two coats Belzona 1321 S-Metal.

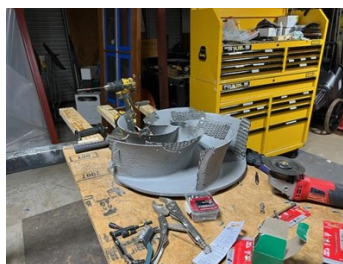
Impeller built up with expanded metal

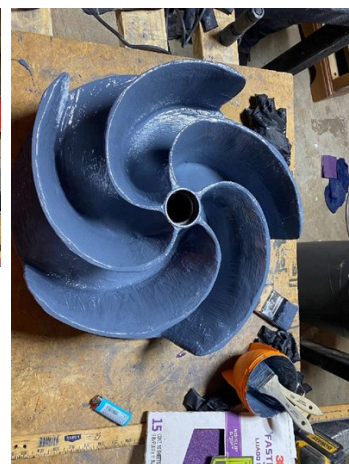
Impeller rebuilt with expanded metal, Belzona 1111 Supermetal, and coated with Belzona 1321 S-Metal.
