# BELZONA FLANGE REFORM GIVES FIVE YEARS OF LEAK FREE SERVICE

ID: 893

Customer Location: FPSO North Sea, UK  
 Application Date: August 2002

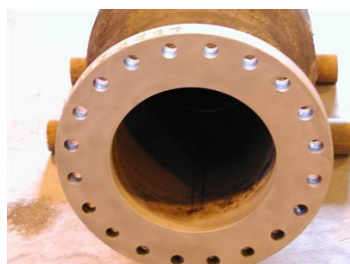
\* Flange face blasted ready for forming Face formed and pressure tested to 16 Bar After 5 years service Close up of the reformed face after 5 years service ,

Application carried out in accordance with Belzona System Leaflet VPF-13.

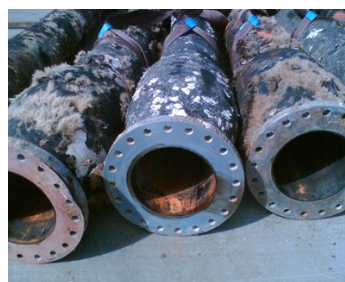
Hose would have been scrapped at a cost of £25,000.00, the string change out would have been delayed leading to a reduction in the unloading frequency from the FPSO. Belzona repair in excellent condition after 5 years in service.
