# Shaft repair on Screw Conveyor

ID: 8933

Industry: *Pulp & Paper*  
Application: *MPT-Mechanical Power Transmission*

Substrate: *Carbon steel*  
Products: *Belzona 1321 (Ceramic S-Metal)*

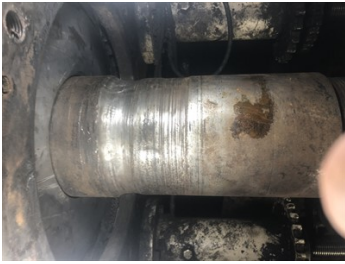
*The customer had a bearing failure which resulted in sever metal loss on the shaft.*

Damaged shaft

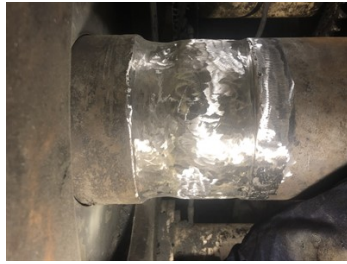
Surface prep in progress

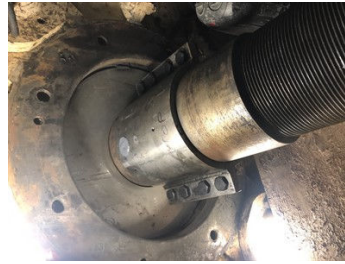
Mold in place and injection of Belzona 1321 Ceramic S Metal complete

A mold was fabricated by the mill and the injection of fluid material Belzona 1321 was chosen and approved by the customer. This was done by guidance of the proper belzona Application Know How document for this application, MPT-02.

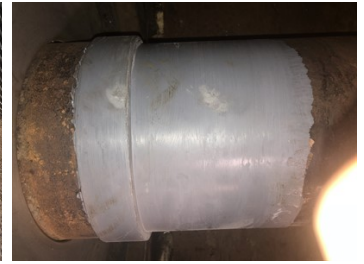
Completed repair
