Shaft repair on Screw Conveyor

Industry: *Pulp & Paper*
Application: *MPT-Mechanical Power Transmission*

Substrate: *Carbon steel*
Products: *Belzona 1321 (Ceramic S-Metal)*

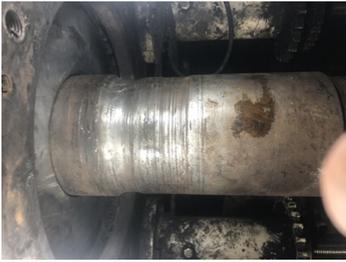
The customer had a bearing failure which resulted in sever metal loss on the shaft.

Damaged shaft

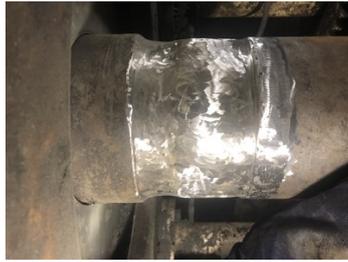
Surface prep in progress

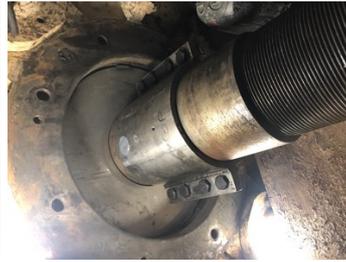
Mold in place and injection of Belzona 1321 Ceramic S Metal complete

A mold was fabricated by the mill and the injection of fluid material Belzona 1321 was chosen and approved by the customer. This was done by guidance of the proper belzona Application Know How document for this application, MPT-02.

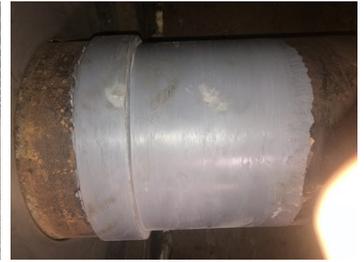
Completed repair
