Shaft repair on Screw Conveyor

ID: 8933

Industry: *Pulp & Paper*
Application: *MPT-Mechanical Power Transmission*

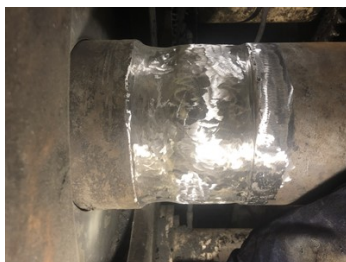
Surface prep in progress
