# PELTON TURBINE NOZZLE HEAD

ID: 8935

Industry:	Water / Wastewater	Customer Location:	California
Application:	CEP-Centrifugal Pumps	Application Date:	December 2022
Substrate:	Carbon steel		
Products:	Belzona 1341 (Supermetalglide), Belzona 2141 (ACR-Fluid Elastomer), Belzona 2941 (Elastomer SP-Conditioner)

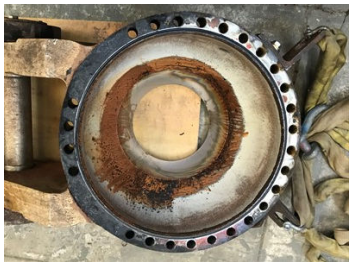
Cavitation damage on the substrate due due to high pressure on the nozzle head

Before / Damage on the Nozzle head

Cavitation was present due to high pressure and high flow rate at the tip of the pelton turbine nozzle head.
