# Belzona Superwrap 2 system repairs storage tank

Industry: *Chemical & Petrochemical* Customer Location: *Scotland*  
Application: *TCC-Tanks and Chemical Containment Areas* Application Date: *January 2023*  
Substrate: *Carbon steel*  
Products: *Belzona 1111 (Super Metal), Belzona 1981 (SuperWrap II)*

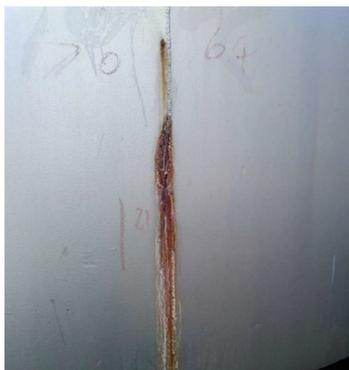
A leak had developed in a storage tank due to corrosion.

Leaking area

The area was prepared with an MBX Bristle Blaster to SSPC SP11. A cold plate bond was then applied using Belzona 1111. This plate was then encapsulated with Belzona Superwrap 2

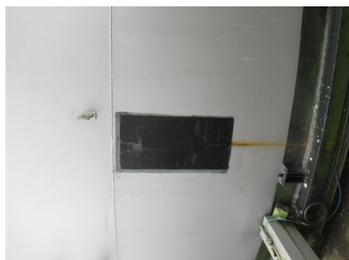
Belzona 1111 & Superwrap 2 applied
