Much Debris Found Under Metal Plate Outside of OR in Local Hospital

ID: 8947

Industry: Other
Application: FPA-Floor Problem Areas
Substrate: Concrete
Products: Belzona 2211 (MP Hi-Build Elastomer), Belzona 2911 (Elastomer QD Conditioner), Belzona 4111 (Magma-Quartz), Belzona 4411 (Granogrip), Belzona 4911 (Magma TX Conditioner)

Customer Location: Piedmont, NC, USA
Application Date: February 2023

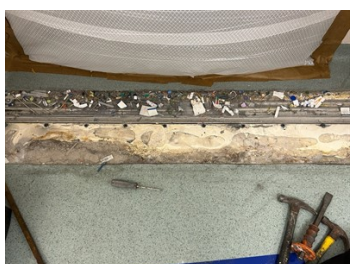
The metal plate covering the expansion joint outside an operating room in a sterile area was trip hazard because the plate was lifting up and separating from the floor. Several employees had tripped and surgical carts toppled from the plate.

Removal of plate reveals extensive amount of debris in a sterile area at doorway to operating room.

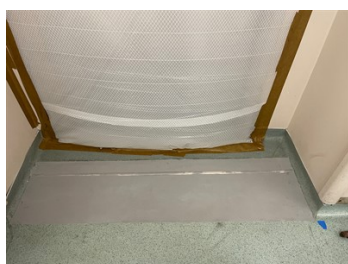
After the plate was removed, the joint was cleaned out and Belzona 4111 was applied to build out the joint nosings.

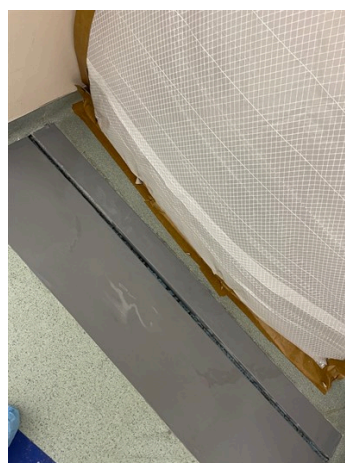
Once Belzona 4111 cured, a thick coating of Belzona 4411 was applied. It was chosen for its fast cure and durability.

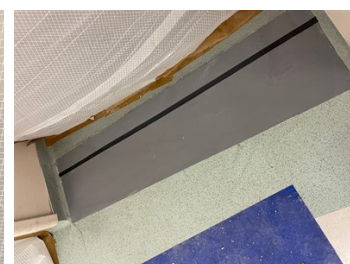
Last step was to condition the joint area with Belzona 2911 and tape off / fill with Belzona 2211 Elastomer.
