# Much Debris Found Under Metal Plate Outside of OR in Local Hospital

**Industry:** Other  
**Application:** FPA-Floor Problem Areas  
**Substrate:** Concrete  
**Products:** Belzona 2211 (MP Hi-Build Elastomer), Belzona 2911 (Elastomer QD Conditioner), Belzona 4111 (Magma-Quartz), Belzona 4411 (Granogrip), Belzona 4911 (Magma TX Conditioner)

**Customer Location:** Piedmont, NC, USA  
**Application Date:** February 2023

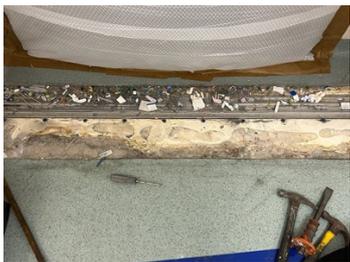
Removal of plate reveals extensive amount of debris in a sterile area at doorway to operating room.
