# BELZONA SEALS LEAK IN OIL STORAGE TANK

**Industry:** Power  
**Application:** TCC-Tanks and Chemical Containment Areas  
**Substrate:** Carbon Steel  
**Products:** \* Belzona® 1161 (Super UW Metal) ,  
\* Belzona® 1111 (Super Metal) ,

**Customer Location:** Power Station, Ravenna, Italy  
**Application Date:** March 2007

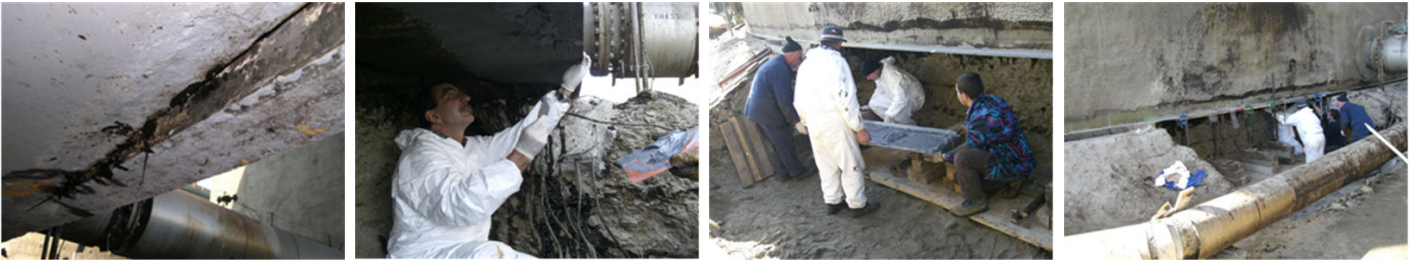
Corrosion of the metal flooring caused a severe leakage of oil into the environment. Welding was not possible.

- \* View of the leakage after the area was blasted ,
- \* Belzona® 1161 being applied ,
- \* Belzona® 1111 applied on the metal plate ,
- \* Positioning and fixing the metal plate with clamps and adjustable risers ,

Application was carried out in accordance with Belzona Know How System Leaflet TCC-1. Area under the leak excavated before doubler plates could be bonded and supported in position with adjustable jacks.
