BELZONA SEALS LEAK IN OIL STORAGE TANK

ID: 895

Industry: Power
Application: TCC-Tanks and Chemical Containment Areas
Substrate: Carbon Steel
Products: * Belzona® 1161 (Super UW Metal) ,
* Belzona® 1111 (Super Metal) ,

Customer Location: Power Station, Ravenna, Italy
Application Date: March 2007

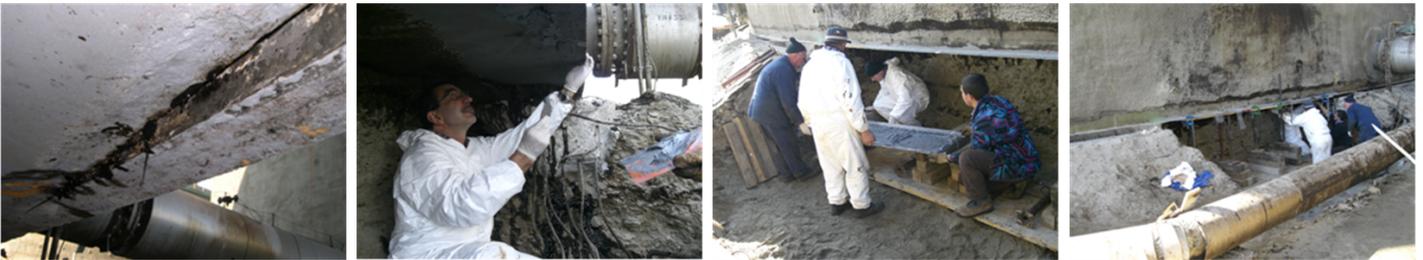
Photograph Descriptions

Corrosion of the metal flooring caused a severe leakage of oil into the environment. Welding was not possible.

- * View of the leakage after the area was blasted ,
- * Belzona® 1161 being applied ,
- * Belzona® 1111 applied on the metal plate ,
- * Positioning and fixing the metal plate with clamps and adjustable risers ,

Application was carried out in accordance with Belzona Know How System Leaflet TCC-1. Area under the leak excavated before doubler plates could be bonded and supported in position with adjustable jacks.
