# Recycled Acid Containment Concrete Repair & Coating

**Industry:** Chemical & Petrochemical  
**Application:** TCC-Tanks and Chemical Containment Areas  
**Substrate:** Concrete  
**Products:** Belzona 4111 (Magma-Quartz), Belzona 4311 (Magma CR1)

**Customer Location:** Decatur, AL, United States  
**Application Date:** December 2021

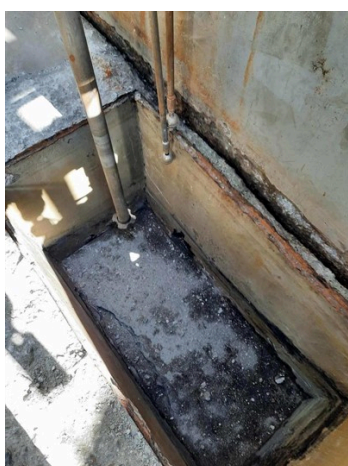
A rubber lined recycled acid day tank occurred a leak in a seam in the liner and exposed the containment to acid. The acid filled the secondary containment almost 2 foot deep and destroyed the previous coating. Over time and years of exposure during filling the small amounts that leaked from the flange and hose caused the damage to the sump pit area.

Damage to the sump pit area.

Using Belzona in this application was decided based upon the chemical in the day tank and years of abuse the containment endured due to spillage during filling. Cost was not a factor in this application due to the amount of damage, it was less expensive for the customer to repair and protect than to demo and replace.

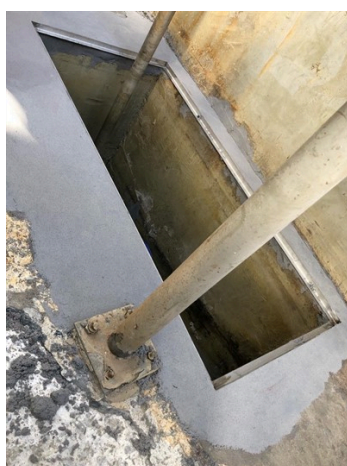
Repairs that were made using Belzona 41111.

In this application we started the process by first pressure washing and neutralizing the concrete to remove any containments and debris. Then there were several cracks we repaired during this project. We drilled the cracks out to stop them from expanding further then created a V in the cracks using hand held grinding tools with diamond disc. We used the same process for the sump pit area. Once all areas were prepped following Belzona guidelines we then made the repairs using hand held tools reforming the sump pit area and coating the containment using hand rollers.

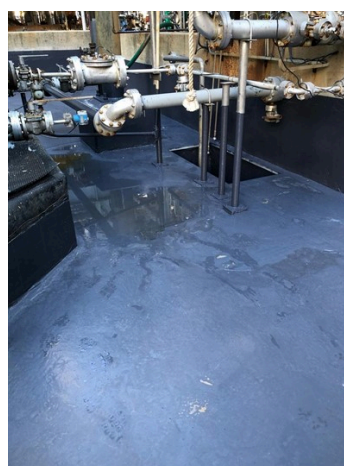
Finished repair and coating. Belzona 4311 was used.
