Belzona repairs sprinkler tank

ID: 8952

Industry: *Food & Drink*
Application: *TCC-Tanks and Chemical Containment Areas*
Substrate: *Carbon steel*
Products: *Belzona 1161 (Super UW-Metal), Belzona 9611 (ES-Metal)*

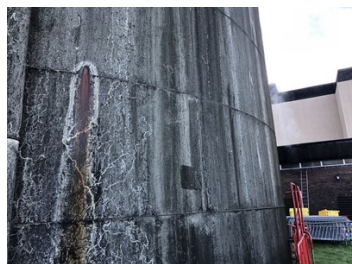
A pinhole leak had developed on the side of a sprinkler tank

Leak on tank

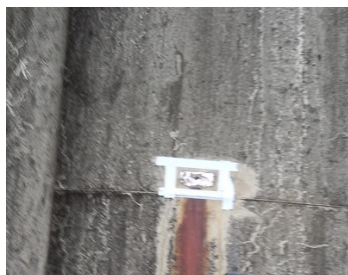
Initial surface preparation

The initial area was first prepared back to bare metal & the leak was sealed with Belzona 9611. Once this was done the larger area was prepared using an angle grinder. A plate was then bonded in place using Belzona 1161 UW Metal

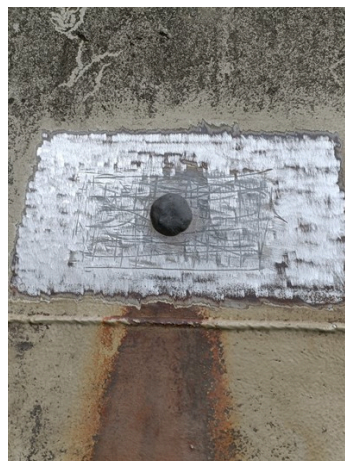
Leak sealed with Belzona 9611 & additional surface preparation carried out

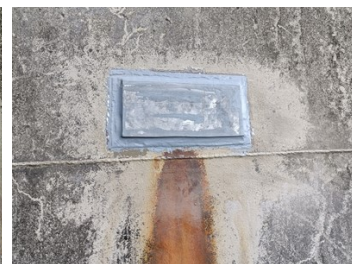
Plate bonded in place with Belzona 1161

By using the Belzona repair system the repair was able to be completed without damaging the tank's internal lining.
