Belzona repairs sprinkler tank

ID: 8952

Application: *TCC-Tanks and Chemical Containment Areas*

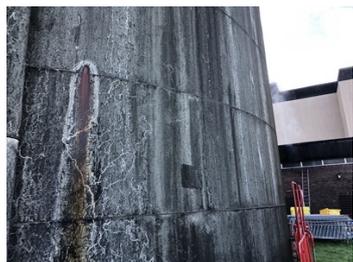
A pinhole leak had developed on the side of a sprinkler tank

Leak on tank

A cold applied repair was required to seal the leak & provide long term reinforcement to the damaged area

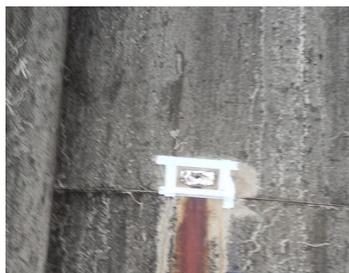
Initial surface preparation

The initial area was first prepared back to bare metal & the leak was sealed with Belzona 9611. Once this was done the larger area was prepared using an angle grinder. A plate was then bonded in place using Belzona 1161 UW Metal

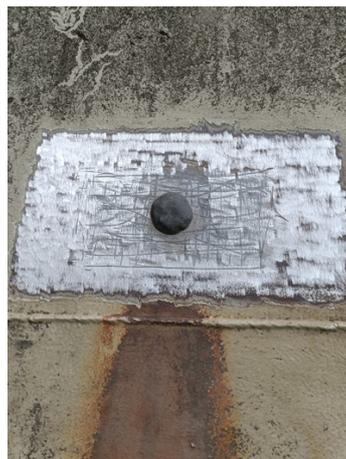
Leak sealed with Belzona 9611 & additional surface preparation carried out

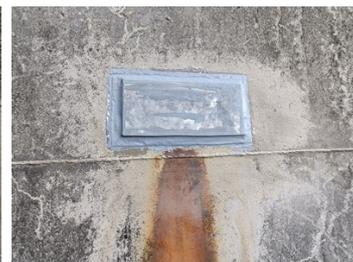
Plate bonded in place with Belzona 1161

By using the Belzona repair system the repair was able to be completed without damaging the tank's internal lining.
