# Belzona Repairs and Protects Spillway from Leaking Oil

ID: 8956

Application: *FPA-Floor Problem Areas*

Substrate: *Concrete*

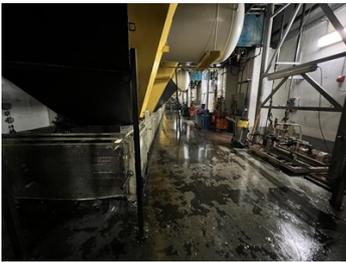
The concrete press pits of the Customer's auto part manufacturing plant had been contaminated by leaking oil, causing environmental risks as well as safety hazards for employees when cleaning machinery. The pits were positioned underneath four conveyor lines which consistently seeped oil onto the concrete. The concrete had previously been sealed only with ordinary paint, but after years in service it could not withstand the constant oil seepage.

Oily substrate prior to application

After 90 days, the trial patch was in excellent condition, leading to the Customer giving their approval for two of the four press pits to be coated during planned seasonal shutdowns. The results of years of oil seepage meant that the substrate required extensive cleaning using Belzona 9111 (Cleaner/Degreaser), steam cleaners and heated pressure washers to get the concrete as clean as possible for the application. The entire surface profile was then prepared using a diamond grinder to facilitate adhesion of Belzona 5831 (ST-Barrier), before a one inch cove was built using Belzona 4111 (Magma-Quartz) at the joints between the floor and the perimeter walls to relieve pressure from the seams. One coat of Belzona 5831 (ST-Barrier) was applied to sumps, flooring and to the

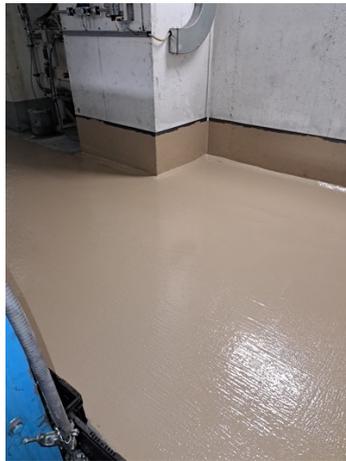
Belzona 4111 (Magma-Quartz) was used to build a cove at the joints with the perimeter walls, and overcoated with Belzona 5831 (ST-Barrier)

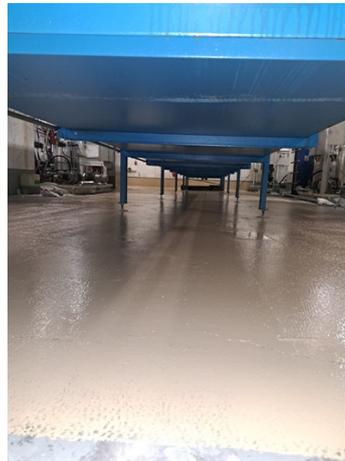
Final coat of Belzona 5831 (ST-Barrier) being applied to all accessible areas

bottom 12 inches of the walls at eight to ten mils Wet Film Thickness (WFT). Before the product had cured, Aluminium Oxide was spread at a rate of 50lbs per 100 square feet to create the desired tread. Finally, a top coat of Belzona 5831 (ST-Barrier) was applied at 10 to 12 mils WFT.

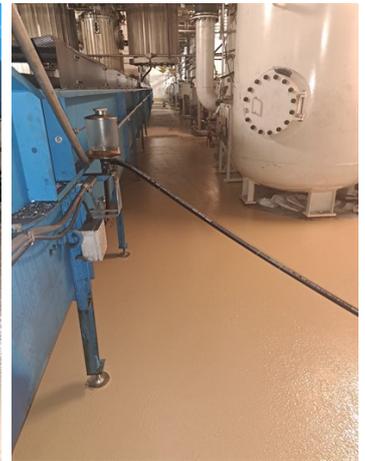
The concrete underneath the conveyor lines were protected and made safer by the repair

Subsequent site visits have shown that the coating is protecting the concrete extremely effectively and the tread is also much safer to walk on. The Customer was very pleased with the work and now has plans to coat the concrete underneath the two remaining conveyor lines and several other press pits, thanks to the success of the Belzona repair.
