# Belzona Repairs and Protects Spillway from Leaking Oil

Application: *FPA-Floor Problem Areas*

Substrate: *Concrete*

Products: *Belzona 4111 (Magma-Quartz), Belzona 5831 (ST-Barrier), Belzona 9111 (Cleaner Degreaser)*

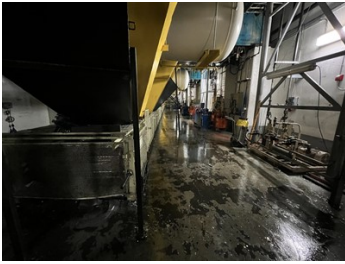
Oily substrate prior to application

After 90 days, the trial patch was in excellent condition, leading to the Customer giving their approval for two of the four press pits to be coated during planned seasonal shutdowns. The results of years of oil seepage meant that the substrate required extensive cleaning using Belzona 9111 (Cleaner/Degreaser), steam cleaners and heated pressure washers to get the concrete as clean as possible for the application. The entire surface profile was then prepared using a diamond grinder to facilitate adhesion of Belzona 5831 (ST-Barrier), before a one inch cove was built using Belzona 4111 (Magma-Quartz) at the joints between the floor and the perimeter walls to relieve pressure from the seams. One coat of Belzona 5831 (ST-Barrier) was applied to sumps, flooring and to the

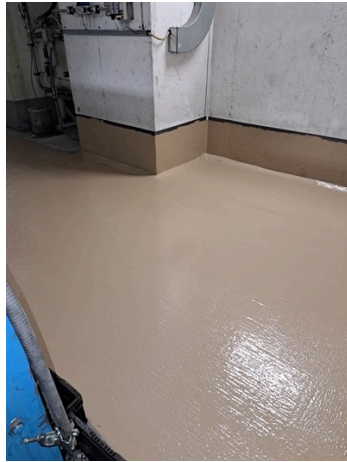
Belzona 4111 (Magma-Quartz) was used to build a cove at the joints with the perimeter walls, and overcoated with Belzona 5831 (ST-Barrier)

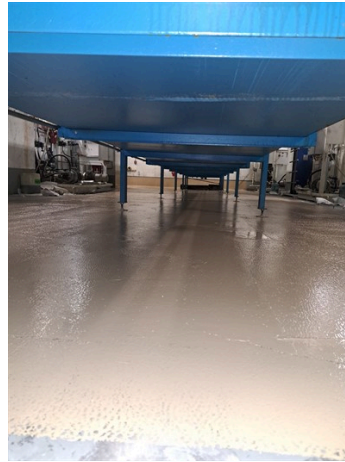
Final coat of Belzona 5831 (ST-Barrier) being applied to all accessible areas

bottom 12 inches of the walls at eight to ten mils Wet Film Thickness (WFT). Before the product had cured, Aluminium Oxide was spread at a rate of 50lbs per 100 square feet to create the desired tread. Finally, a top coat of Belzona 5831 (ST-Barrier) was applied at 10 to 12 mils WFT.

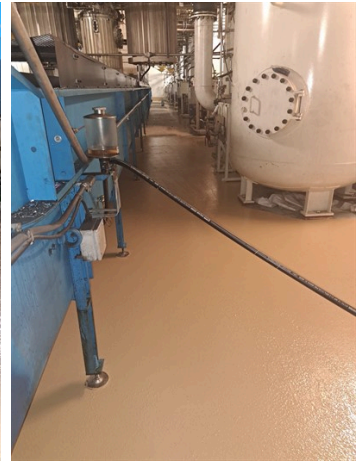
The concrete underneath the conveyor lines were protected and made safer by the repair

Subsequent site visits have shown that the coating is protecting the concrete extremely effectively and the tread is also much safer to walk on. The Customer was very pleased with the work and now has plans to coat the concrete underneath the two remaining conveyor lines and several other press pits, thanks to the success of the Belzona repair.
