LUXURY YACHT P FRAMES PROTECTED FROM CAVITATION WITH BELZONA® 2141

ID: 897

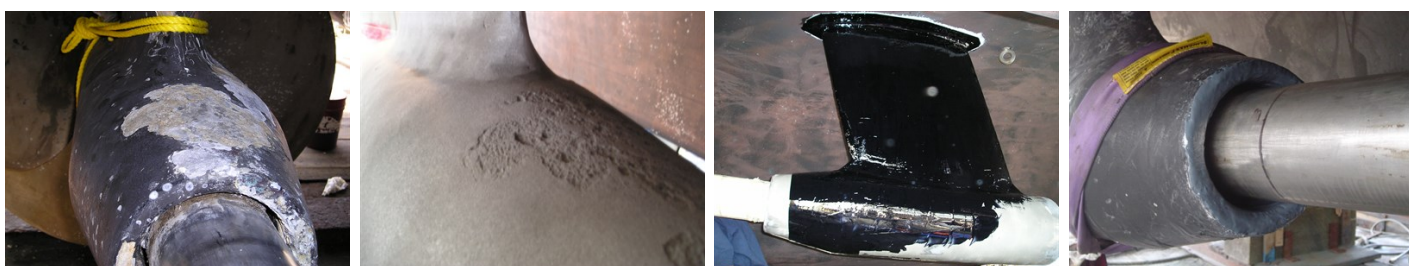
Photograph Descriptions

Cavitation had caused erosion of the parent metal and threatened the structural strength of the component if left untreated.

- * Original condition of component ,
- * Close up of cavitation damage ,
- * Belzona® 2141 mid application ,
- * Belzona® 2141 after 12 months (overcoated with antifouling) ,

Propeller shaft support brackets of a luxury yacht. This craft is 46.63m long and equipped with a 13,000hp CODAG power plant capable of 50 Knots through a combined twin-prop and waterjet arrangement.

Application was carried out in accordance with Belzona Know-How System Leaflet SOS-2. A conventional anti-fouling was applied over the Belzona® 2141.

Inspection of the Belzona® 2141 system after 12 months service in this aggressive environment showed no attack to the Belzona coating.
