Belzona Repairs a Conveyor Belt for a Robotised Pharmaceutical Depot

ID: 8992

Application: SHM-Solids Handling Machinery

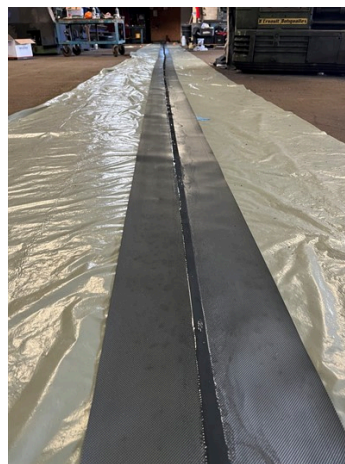
The finished and repaired conveyor belt.

The conveyor belt was prepared by cutting out the damaged rip in order to ensure a clean application. A reinforcement sheet (Belzona 9341) was used in conjunction with a multipurpose liquid elastomer (Belzona 2221). The application was carried out in accordance with a modified version of Belzona System Leaflet SHM-01.

The approved Belzona Distributor, conducted this repair and was able to put the conveyor belt back in service in less than 24-hours.
