# Belzona Repairs a Conveyor Belt for a Robotised Pharmaceutical Depot

ID: 8992

Application: *SHM-Solids Handling Machinery*

Application Date: *February 2023*

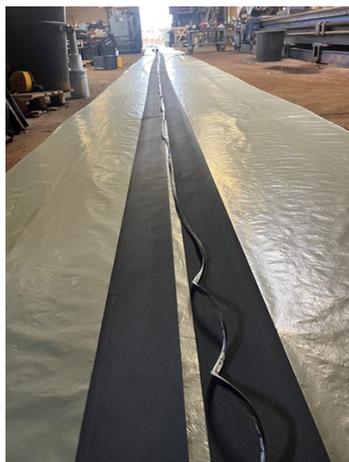
The conveyor belt mid-preparation.

The conveyor belt was prepared by cutting out the damaged rip in order to ensure a clean application. A reinforcement sheet (Belzona 9341) was used in conjunction with a multipurpose liquid elastomer (Belzona 2221). The application was carried out in accordance with a modified version of Belzona System Leaflet SHM-01.

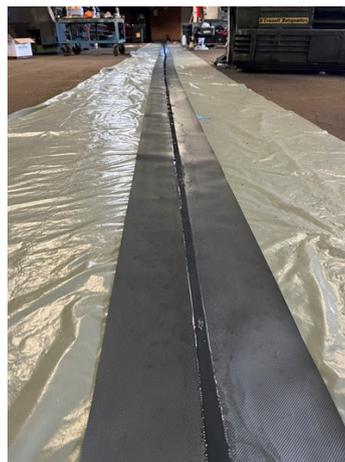
The finished and repaired conveyor belt.

The approved Belzona Distributor, conducted this repair and was able to put the conveyor belt back in service in less than 24-hours.
