# Chemical floor drains

ID: 8994

Application: FPA-Floor Problem Areas

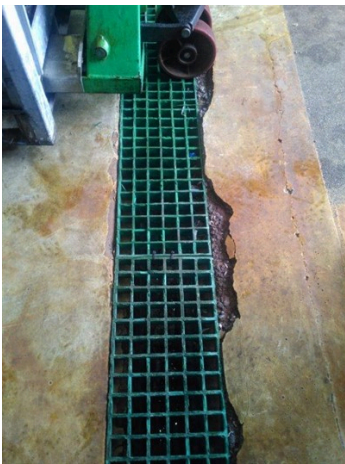
Loose grates and crack shoulders, requiring rebuilding using 4181

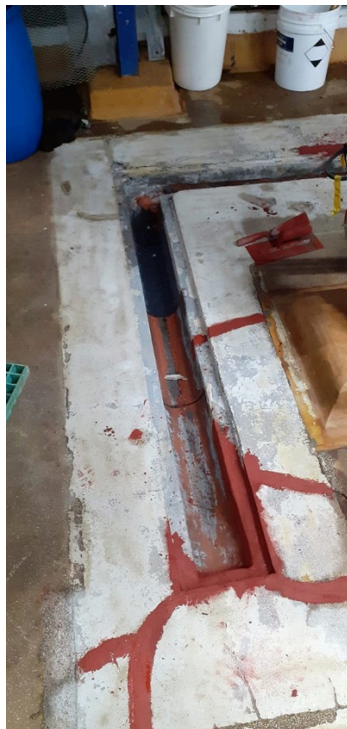
Work ongoing

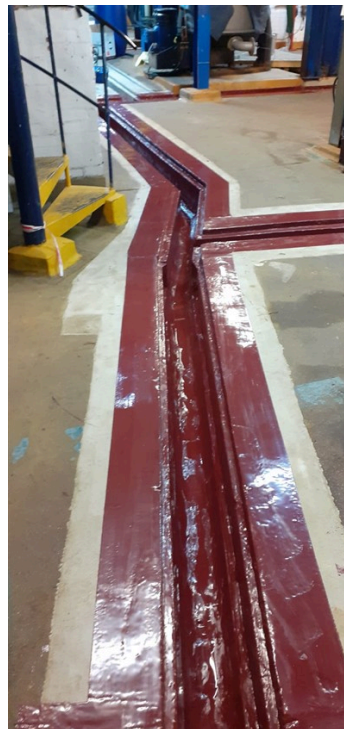
Completed 4181 concrete repairs and 4331 coating

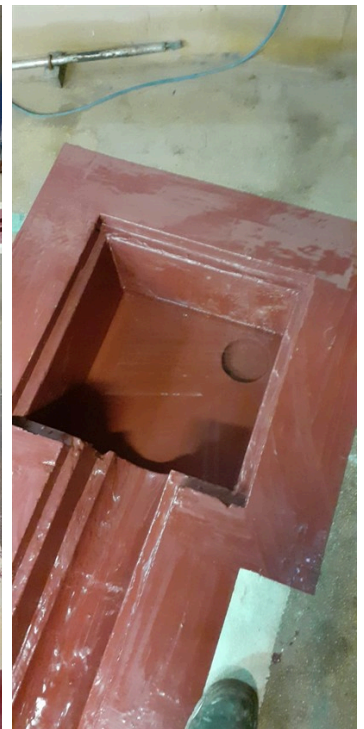
Completed 4181 concrete repairs and 4331 coating
