Chemical floor drains

ID: 8994

Industry: Chemical & Petrochemical
Application: FPA-Floor Problem Areas
Substrate: Concrete
Products: Belzona 4181 (AHR Magma-Quartz), Belzona 4331 (Magma CR3)

Customer Location: Loughborough
Application Date: September 2020

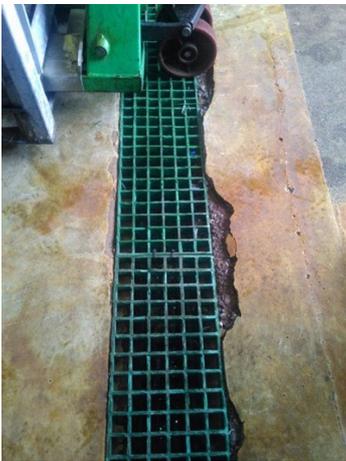
A network of floor drains had found to be compromised by age, wear and harsh chemical attack. The chemicals included were Sulphuric, Hydrochloric, Nitric, Methanol and Acetone, amongst a cocktail of others. Percentages varied, but could reach as high as 50%, though only on very rare occasions.

Concerns were that the chemicals were escaping into the ground through damaged drains, causing serious environmental concerns

Loose grates and crack shoulders, requiring rebuilding using 4181

Carry out surface preparation to the required standard, removing surface contamination and loose concrete/repair material.

Mix and apply Belzona® 4911 surface conditioner to areas within drain channel for repair.

Mix and apply Belzona® 4181 to drain channel profile. This will be done by trowel but may also be aided with form work.

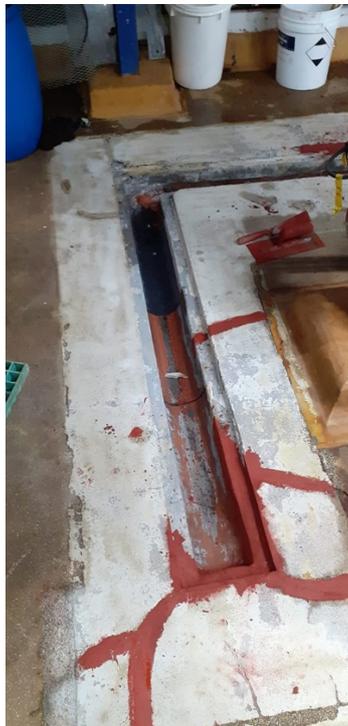
Work ongoing

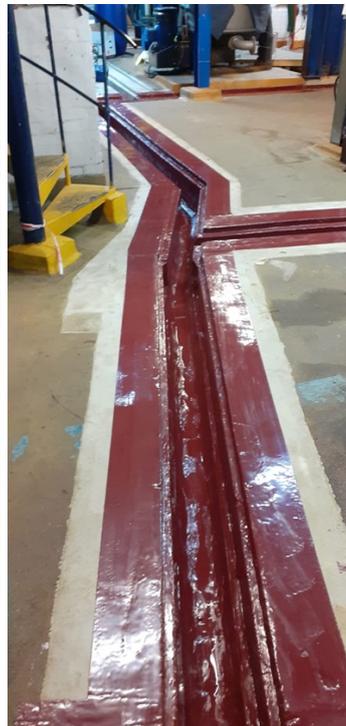
Completed 4181 concrete repairs and 4331 coating

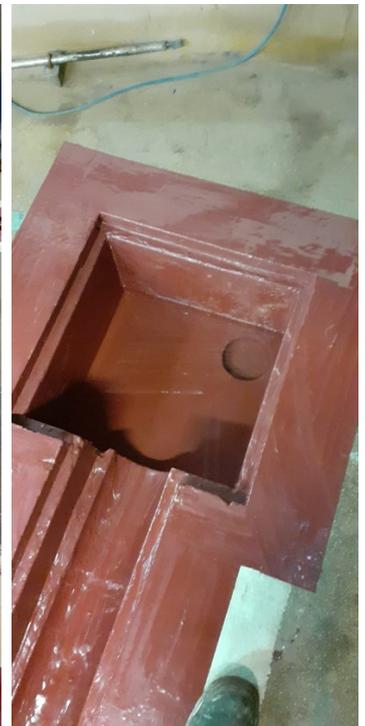
Completed 4181 concrete repairs and 4331 coating
