# BELZONA PROTECTS FAST FERRY BOW THRUSTERS FROM CAVITATION

ID: 900

Industry: *Marine*  
 Application: *SOS-Ships and Offshore Structures*

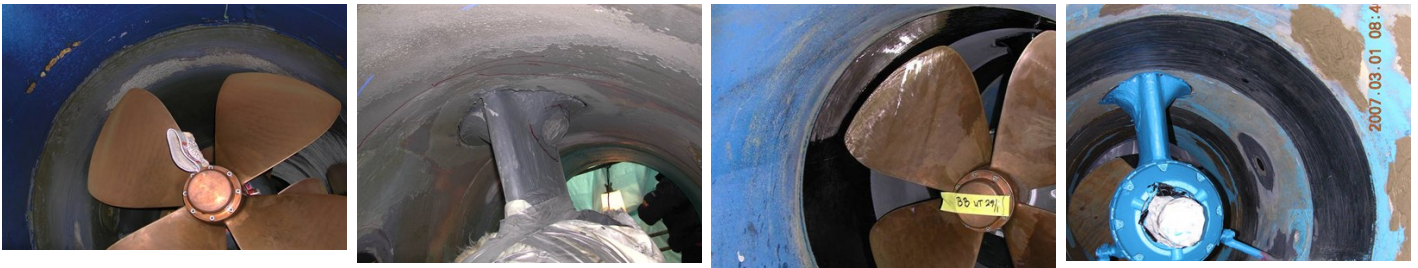
*Cavitation problems had manifested themselves in the Port and Starboard Bow Thruster Tunnels. Annual repairs had been attempted with glass flake coatings and Belzona® 1341, but none had been ideal allowing metal loss to continue in the tunnel.*

\* Localized damage to Belzona® 1341 (Port) Extensive damage to Glass Flake lining (Starboard) Belzona® 2141 (Portside)  
 Inspection after 5 years service ,

Following removal of the existing coatings Belzona® 2141 was applied in accordance with a modified version of SOS-1 and SOS-2.

Subsequent annual inspections have shown the Belzona® 2141 to provide outstanding cavitation protection. After nine (9) years in service the Belzona 2141 remains in excellent condition apart from a few mm<sup>2</sup> of mechanical damage. The client is extremely pleased with the application which has allowed them to extend the annual docking cycle to a bi-annual one
