Rubber Lining on Limestone Filter Tank Replaced with Belzona's Epoxy Lining

ID: 9006

Industry: Power

Customer Location: Ras Laffan, Doha, Qatar

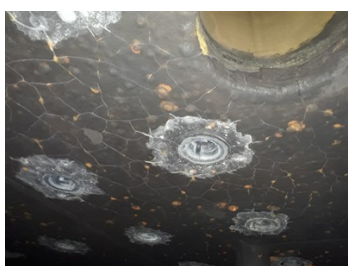
Cracks, blisters, delaminations and alligating were found in the existing rubber lining of the tank after a long period of use without maintenance.

Cracking on the original rubber lining

Damaged areas of the existing rubber lining were removed and the exposed metal surface was grit blasted. Exposed deeply pitted areas were filled with Belzona 1111 and rebuilt up to 1 mm to compensate for metal loss. Multiple coats of Belzona 1321 were applied by brush for extra protection.

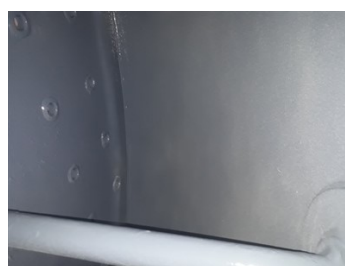
Initial coat of Belzona 1321 being applied

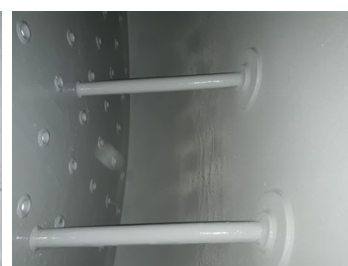
Application completed and protected tank inner surfaces
