Rubber Lining on Limestone Filter Tank Replaced with Belzona's Epoxy Lining

ID: 9006

Industry: Power
Application: TCC-Tanks and Chemical Containment Areas
Substrate: Carbon steel
Products: Belzona 1111 (Super Metal), Belzona 1321 (Ceramic S-Metal)

Customer Location: Ras Laffan, Doha, Qatar
Application Date: June 2016

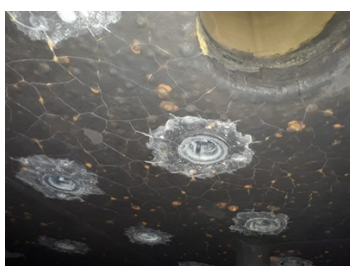
Cracks, blisters, delaminations and alligatoring were found in the existing rubber lining of the tank after a long period of use without maintenance.

Cracking on the original rubber lining

Damaged areas of the existing rubber lining were removed and the exposed metal surface was grit blasted. Exposed deeply pitted areas were filled with Belzona 1111 and rebuilt up to 1 mm to compensate for metal loss. Multiple coats of Belzona 1321 were applied by brush for extra protection.

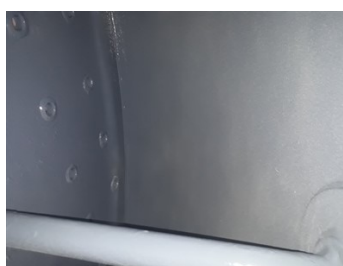
Initial coat of Belzona 1321 being applied
