# Belzona repairs vessel skag

ID: 9009

Industry: Marine  
Application: SOS-Ships and Offshore Structures

Substrate: Carbon steel  
Products: Belzona 1111 (Super Metal)

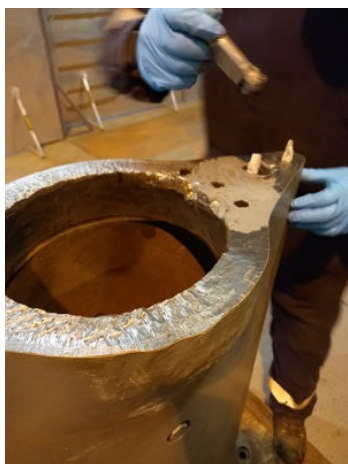
Erosion & corrosion had taken its toll on a marine skag. There was significant metal loss in need of repair before the part could go back into service

Surface preparation carried out & Belzona 1111 applied

The corroded areas were prepared using grinding tools to get back to bare metal & to roughen the surface. Belzona 1111 was then applied ~2mm proud of the surface. Applicator tools were used to form the inner bearing surface. Once the Belzona 1111 had reached its initially cure stage it was machined back down to the original equipment dimensions.

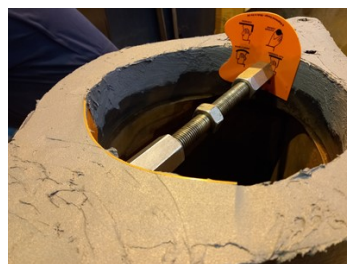
Close up of inner edge forming

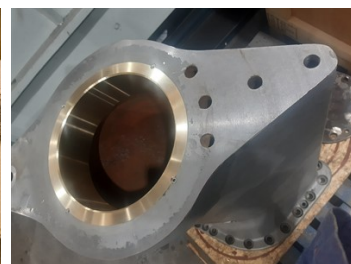
The repair area machined back down to the required dimensions
