Belzona repairs vessel skag

ID: 9009

Industry: *Marine*
Application: *SOS-Ships and Offshore Structures*

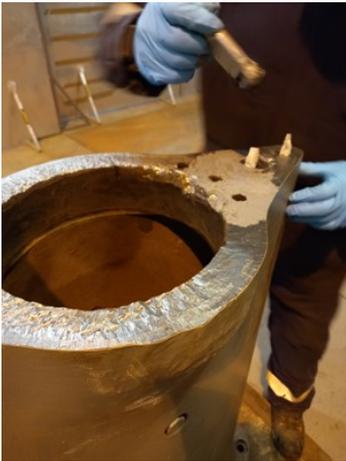
Surface preparation carried out & Belzona 1111 applied

The corroded areas were prepared using grinding tools to get back to bare metal & to roughen the surface. Belzona 1111 was then applied ~2mm proud of the surface. Applicator tools were used to form the inner bearing surface. Once the Belzona 1111 had reached its initially cure stage it was machined back down to the original equipment dimensions.
