# BELZONA® 2141 PROTECTS FRANCIS TURBINE RUNNERS FROM CAVITATION

ID: 901

**Customer Location:** Hydroelectric plant (Ontario, Canada)  
**Application Date:** August 1998 and July 2001

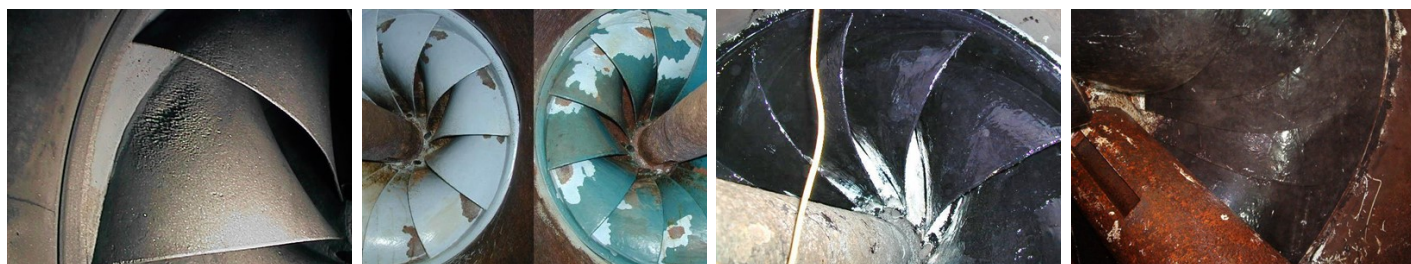
*Cavitation had caused erosion of the parent metal and loss of performance of the turbine. Belzona® 1341 and Belzona® 1421 had been applied in 1998 but had suffered erosion in this aggressive environment.*

- \* Cavitation damage ,
- \* Belzona® 1341 (left) and Belzona® 1421 (right) after 36 months service ,
- \* Belzona® 2141 after application ,
- \* Belzona® 2141 after 34 months ,

Twin 914mm (36 inch) Francis Turbine Runners operating with 13m (42 feet) head and constructed in 1945.

Application was carried out in accordance with Belzona Know-How System Leaflet CEP-3.

Inspection of the Belzona® 2141 in 2002 showed no damage – further inspection after 34 months showed no sign of damage to the coating.
