# Repair of damaged pump parts

ID: 9013

Industry: Oil & Gas  
Application: CEP-Centrifugal Pumps  
Substrate: Carbon steel  
Products: Belzona 1111 (Super Metal), Belzona 5821

Customer Location: Jubail  
Application Date: November 2022

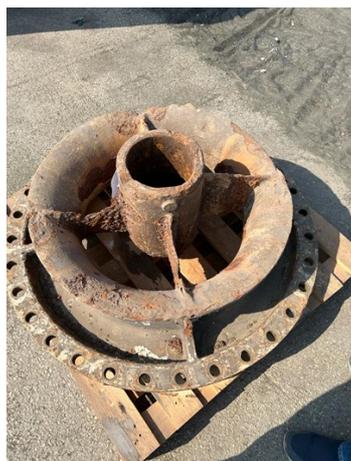
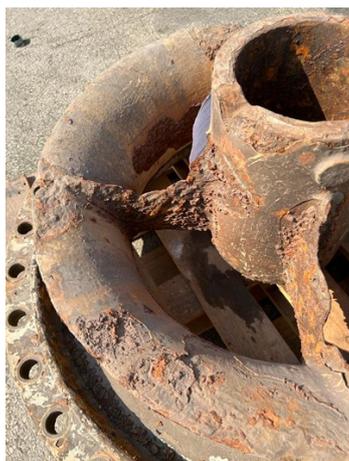
The pump part was heavily corroded and eroded and not in a condition to use

Initial condition

Initial Condition

Customer was unable to find a replacement part and was in a situation not getting the part from manufacturer because of the outdated design.

The application was completed in accordance with Belzona System Leaflets CEP 01, CEP 03 and CEP 05

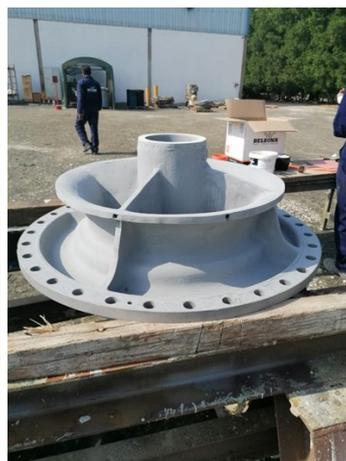
After repair with Belzona 1111

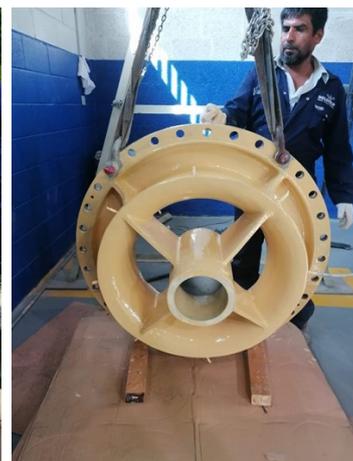
After coating with Belzona 5821
