Belzona Cold-Bonded Doubler Plates to Restore Holed Deck on Offshore Platform

Industry: Oil & Gas
Application: GSS-Gaskets, Seals and Shims
Substrate: Carbon steel
Products: Belzona 1111 (Super Metal), Belzona 1121 (Super XL-Metal), Belzona 5231 (SG Laminate), Belzona 5233, Belzona 5811 (Immersion Grade)

Customer Location: Offshore Refinery, Qatar
Application Date: January 2020

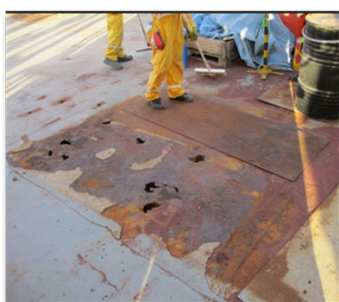
The client had problems with pitting and holes in the platform deck as a result of corrosion. This had resulted in an unsafe and insecure platform structures, which was hampering operations.

Holes in the surface plate of the deck due to severe corrosion

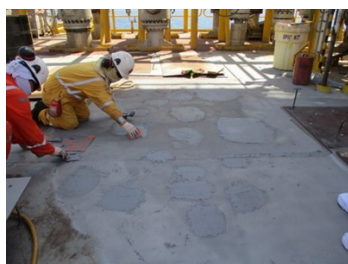
Holes were sealed and pitted areas were filled using Belzona 1111 and 1121

Repair areas on the deck surface were cleaned and properly prepared. Holes, uneven areas, deep voids and pitting were sealed, filled and levelled using Belzona 1111 and 1121. Doubler plates were located in place, checking for level and alignment, and their edges and joints were sealed with Belzona 1121. Belzona 5811 was injected into the doubler plates to fill gaps and voids under the plates and provide adhesion and mechanical strength. The final finish was Belzona 5231 and 5233 (a UV resistant, anti-slip floor coating system) to protect the restored deck top from environmental degradation.

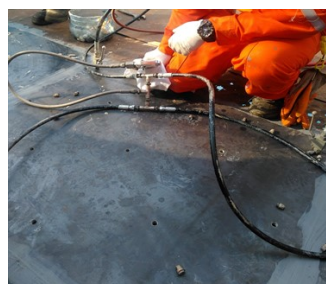
Inject Belzona 5811 to cold bond the doubler plate located
