Belzona Cold-Bonded Doubler Plates to Restore Holed Deck on Offshore Platform

Customer Location: Offshore Refinery, Qatar
Application Date: January 2020

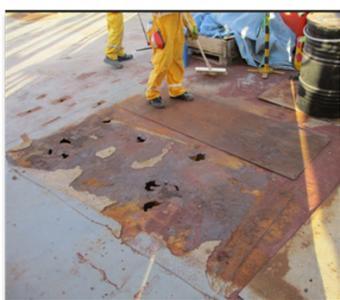
The client had problems with pitting and holes in the platform deck as a result of corrosion. This had resulted in an unsafe and insecure platform structures, which was hampering operations.

Holes in the surface plate of the deck due to severe corrosion

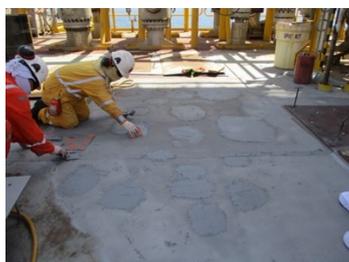
Holes were sealed and pitted areas were filled using Belzona 1111 and 1121

Repair areas on the deck surface were cleaned and properly prepared. Holes, uneven areas, deep voids and pitting were sealed, filled and levelled using Belzona 1111 and 1121. Doubler plates were located in place, checking for level and alignment, and their edges and joints were sealed with Belzona 1121. Belzona 5811 was injected into the doubler plates to fill gaps and voids under the plates and provide adhesion and mechanical strength. The final finish was Belzona 5231 and 5233 (a UV resistant, anti-slip floor coating system) to protect the restored deck top from environmental degradation.

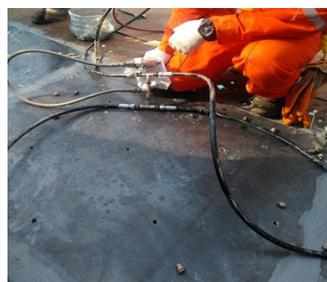
Inject Belzona 5811 to cold bond the doubler plate located
