Belzona Cold-Bonded Doublers Plates to Restore Holed Deck on Offshore Platform

Customer Location: Offshore Refinery, Qatar
Application Date: January 2020

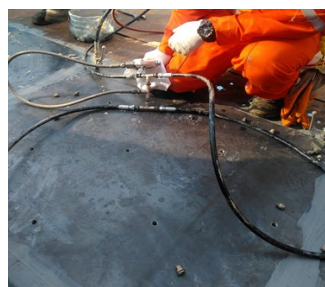
Inject Belzona 5811 to cold bond the doubler plate located

Once the bonding application of the doubler plates is completed, the deck top was coated with Belzona 5231 and 5233

Repair areas on the deck surface were cleaned and properly prepared. Holes, uneven areas, deep voids and pitting were sealed, filled and levelled using Belzona 1111 and 1121. Doublers plates were located in place, checking for level and alignment, and their edges and joints were sealed with Belzona 1121. Belzona 5811 was injected into the doubler plates to fill gaps and voids under the plates and provide adhesion and mechanical strength. The final finish was Belzona 5231 and 5233 (a UV resistant, anti-slip floor coating system) to protect the restored deck top from environmental degradation.
