Belzona Saves Daycare \$30k with 2311

Application: FPA-Floor Problem Areas

Products: Belzona 2311 (SR Elastomer), Belzona 2911 (Elastomer QD Conditioner)

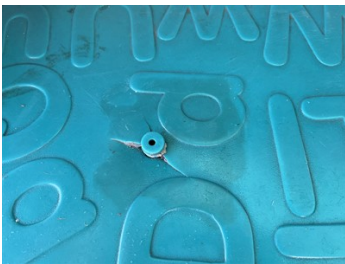
The customer was facing a challenge with their 20-year-old hard plastic playground flooring. Over the years, five "blow holes" in the flooring had been designed to release air as children played on the surface. However, these air holes eventually became flexible and developed cracks around their bases, posing a safety risk to the children. There was a concern that small fingers could become trapped or injured due to these compromised areas.

Blow holes with cracks formed around it

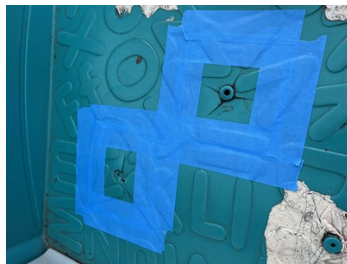
Preparation of the application area

Given that the playground floor was made from a material we don't typically bond to, it was crucial to create a suitable surface profile for the repair. To achieve this, we first taped off the surrounding areas to maintain a clean, aesthetic appearance. Then, we

used the Belzona roughing brush to create a "hairy" texture on the surface, ensuring a strong bond with the elastomer.

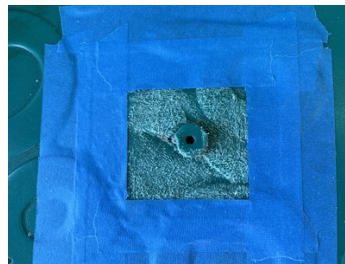
Area after surface preparation

For optimal adhesion, we applied Belzona 2911 conditioner to the prepared substrate. We then mixed two small packets of Belzona 2311 and promptly applied the mixture to the five problem areas using a Belzona tool.

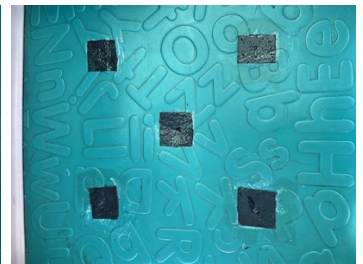
Application completed and protected with Belzona 2311

After allowing the repair to cure for a day, the playground floor showed excellent performance under light foot traffic, effectively addressing all safety concerns. This repair method provided a straightforward and efficient solution for the customer, while maintaining professional quality and ease of understanding.
