Belzona Saves Daycare \$30k with 2311

ID: 9022

Industry: Buildings & Structures
Application: FPA-Floor Problem Areas
Substrate: Other
Products: Belzona 2311 (SR Elastomer), Belzona 2911 (Elastomer QD Conditioner)

Customer Location: Hoover, Alabama
Application Date: January 2023

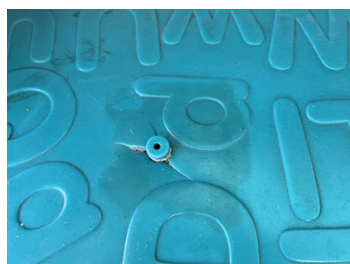
The customer was facing a challenge with their 20-year-old hard plastic playground flooring. Over the years, five "blow holes" in the flooring had been designed to release air as children played on the surface. However, these air holes eventually became flexible and developed cracks around their bases, posing a safety risk to the children. There was a concern that small fingers could become trapped or injured due to these compromised areas.

Blow holes with cracks formed around it

We suggested using Belzona 2311 and 2911 to repair the cracked floor areas. With this approach, the customer saved a considerable amount of money compared to replacing the whole playground. This solution also took less time than installing a new playground set while ensuring the children's safety.
