Belzona Saves Daycare \$30k with 2311

Application: FPA-Floor Problem Areas

Products: Belzona 2311 (SR Elastomer), Belzona 2911 (Elastomer QD Conditioner)

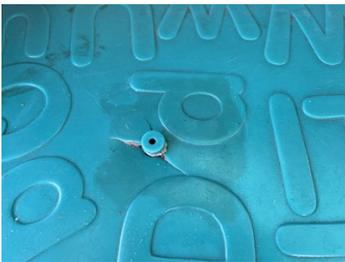
The customer was facing a challenge with their 20-year-old hard plastic playground flooring. Over the years, five "blow holes" in the flooring had been designed to release air as children played on the surface. However, these air holes eventually became flexible and developed cracks around their bases, posing a safety risk to the children. There was a concern that small fingers could become trapped or injured due to these compromised areas.

Blow holes with cracks formed around it

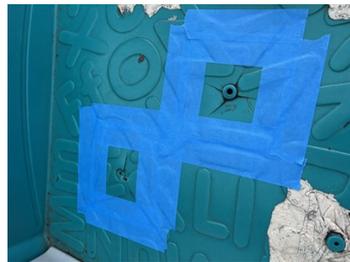
Preparation of the application area

Given that the playground floor was made from a material we don't typically bond to, it was crucial to create a suitable surface profile for the repair. To achieve this, we first taped off the surrounding areas to maintain a clean, aesthetic appearance. Then, we

used the Belzona roughing brush to create a "hairy" texture on the surface, ensuring a strong bond with the elastomer.

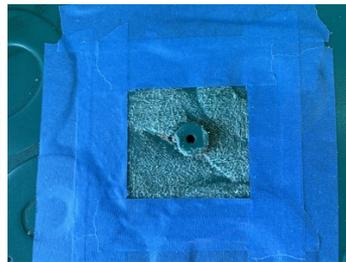
Area after surface preparation

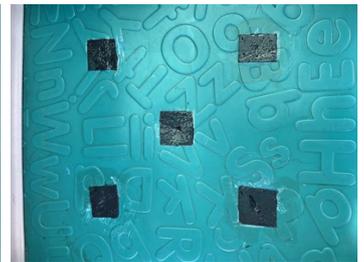
Application completed and protected with Belzona 2311

For optimal adhesion, we applied Belzona 2911 conditioner to the prepared substrate. We then mixed two small packets of Belzona 2311 and promptly applied the mixture to the five problem areas using a Belzona tool.

After allowing the repair to cure for a day, the playground floor showed excellent performance under light foot traffic, effectively addressing all safety concerns. This repair method provided a straightforward and efficient solution for the customer, while maintaining professional quality and ease of understanding.
