# Sealing of the High School Orchestra Pit

ID: 9025

Industry: Buildings & Structures  
Application: FPA-Floor Problem Areas  
Substrate: Concrete  
Products: Belzona 3121 (MR7), Belzona 4111 (Magma-Quartz), Belzona 5811 (Immersion Grade)

Customer Location: Washington, NC  
Application Date: February 2023

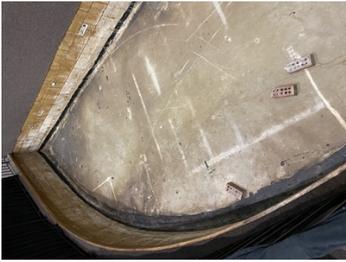
Local High School was experiencing ground water seepage into their Orchestra pit. As a result, all practices were postponed indefinitely until the pit was repaired.

Damage area

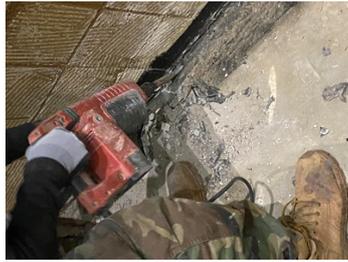
Preparing the surface

Old repairs were removed with the use of hand tools. Cove was build using Belzona 41111 and then sealed with Belzona 3121. Two-coat system of Belzona 5811 was then applied to entire orchestra pit.

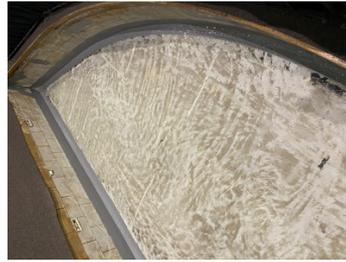
4111 and 3121 application

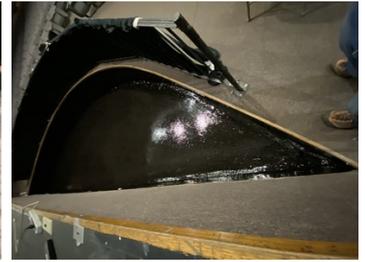
5811 top coat was applied
