# Belzona Makes 50 Year Old Sand Filter Pumps Feel Young Again

ID: 9027

Industry: Marine  
Application: CEP-Centrifugal Pumps  
Substrate: Bronze  
Products: Belzona 1311 (Ceramic R-Metal), Belzona 1331

Customer Location: Galveston, Texas  
Application Date: 2022

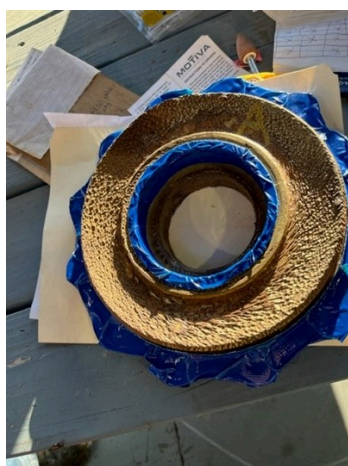
These 50 year old pumps were getting very close to their end of life from sand filtering water service aboard tow boats in the brown waters in the Gulf of Mexico. The client did not want to re-design a new system due to the pumps not being made for the last 15 years by the manufacturer.

Backing Plate showing sings of extreme erosion from years of sandy water service.

The pumps were brought to the shop, de-salted, blasted to above a 3-mil average, rebuilt with 1311 and coated with two coats of 1331.

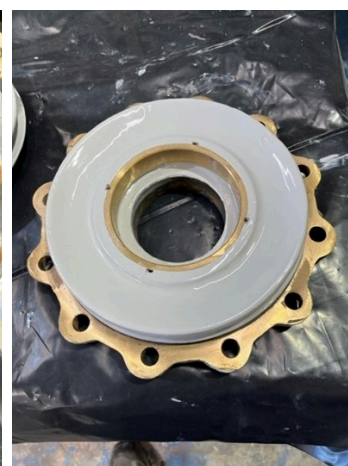
Backing plate feeling young again after being rebuilt and coated.
