# Belzona Makes 50 Year Old Sand Filter Pumps Feel Young Again

ID: 9027

Industry: Marine  
Application: CEP-Centrifugal Pumps  
Substrate: Bronze  
Products: Belzona 1311 (Ceramic R-Metal), Belzona 1331

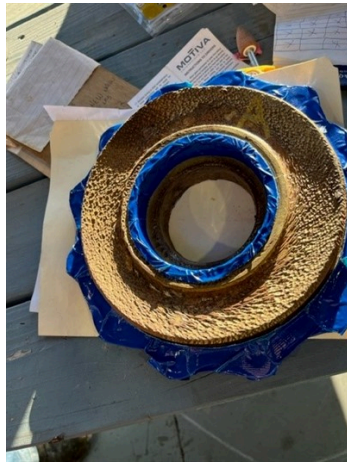
These 50 year old pumps were getting very close to their end of life from sand filtering water service aboard tow boats in the brown waters in the Gulf of Mexico. The client did not want to re-design a new system due to the pumps not being made for the last 15 years by the manufacturer.

Backing Plate showing signs of extreme erosion from years of sandy water service.

The pumps were brought to the shop, de-salted, blasted to above a 3-mil average, rebuilt with 1311 and coated with two coats of 1331.

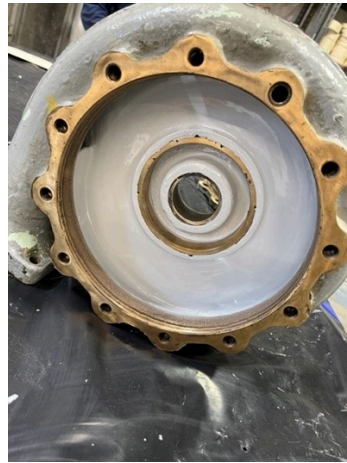
Freshly rebuilt and coated casing ready for more years of service.

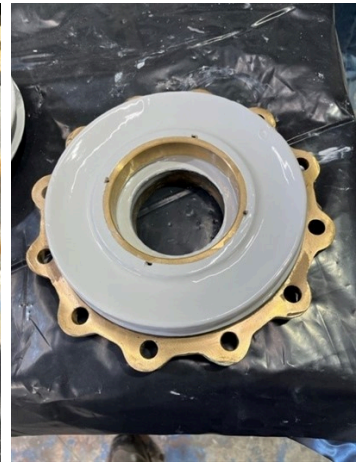
Backing plate feeling young again after being rebuilt and coated.
