# Belzona Makes 50 Year Old Sand Filter Pumps Feel Young Again

ID: 9027

Application: CEP-Centrifugal Pumps

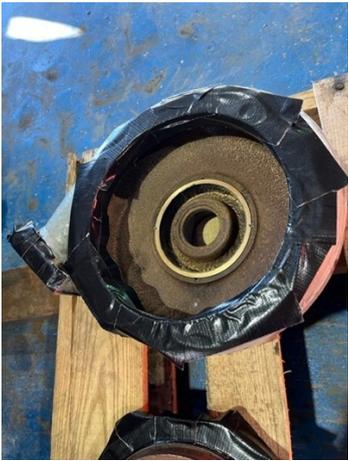
These 50 year old pumps were getting very close to their end of life from sand filtering water service aboard tow boats in the brown waters in the Gulf of Mexico. The client did not want to re-design a new system due to the pumps not being made for the last 15 years by the manufacturer.

Casing showing signs of extreme erosion from years of sandy water service.

The pumps were brought to the shop, de-salted, blasted to above a 3-mil average, rebuilt with 1311 and coated with two coats of 1331.

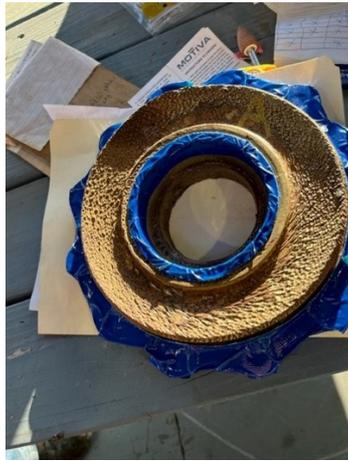
Backing Plate showing signs of extreme erosion from years of sandy water service.

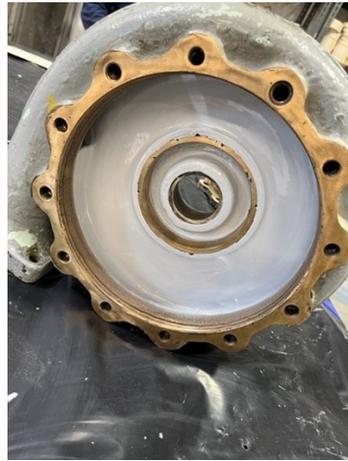
Freshly rebuilt and coated casing ready for more years of service.

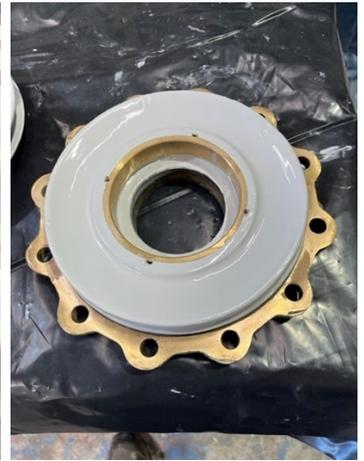
Backing plate feeling young again after being rebuilt and coated.
