# ACID CONTAINMENT FLOOR RE-HAB WITH BELZONA

**Industry:** Buildings & Structures  
**Application:** FPA-Floor Problem Areas  
**Substrate:** Concrete  
**Products:** \* Belzona® 5811 (Immersion Grade) ,  
\* Belzona® 9541 (Bulkfill) ,  
\* Belzona® 9221 (Surefoot Aggregate) ,

**Customer Location:** Water Treatment Plant, OK  
**Application Date:** July 2007

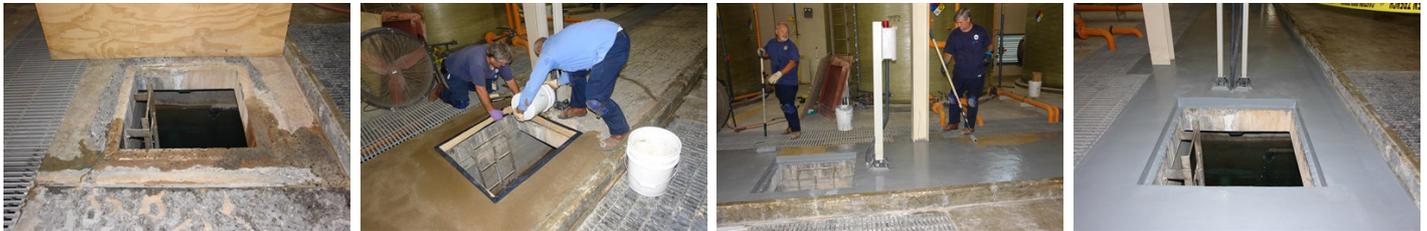
Caustic and Fluoride spills due to pump leaks had eaten through the floor coating, down to the aggregate in some places, and destroyed the metal framework for the access way into the sump below. Previous coating failed and presented a slippery floor when hosed down.

- \* Floor prepared for re-surfacing ,
- \* Re-shaping the access opening Belzona® 5811 ,
- \* Grey coat over beige with Surefoot added ,
- \* Rebuilt, protected, a first class job! ,

Application was carried out in accordance with Belzona Know-How System Leaflets FPA-1 & 3. Bulkfill was used to rebuild the sump access and spalled areas. The entire area was then given two coats of Immersion Grade with Surefoot Aggregate applied to achieve safe footing.
