Belzona Beefs up Rock Box Wear Pad

ID: 9030

Industry: *Marine*
Application: *SHM-Solids Handling Machinery*

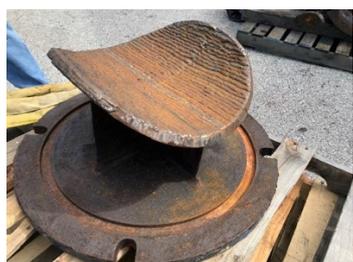
Weld overlay wasnt enough for the wear pads of this dredging rock box. This wear pad will see anything from mud, sand, oysters, rocks, dropped tools in the bottom of the ship channel, and many other hard objects picked up by the dredging pump.

Wear Plate Before

Blasted to SSPC-SP10 - minimum 3-mil anchor

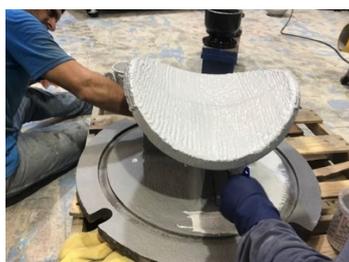
Priming coat of Belzona 1331

Primer coat of Belzona 1331 to increase adhesion of the Belzona 1814

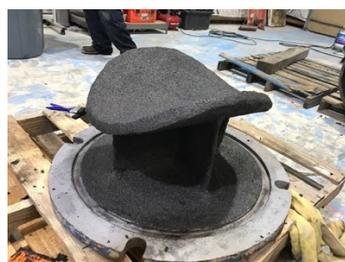
Finished coat of Belzona 1814

1/4" of Belzona 1814 applied to all wear surfaces
