Emergency Floor Repair with Belzona 4111

Application: FPA-Floor Problem Areas

Substrate: Concrete

Products: Belzona 4111 (Magma-Quartz), Belzona 4911 (Magma TX Conditioner)

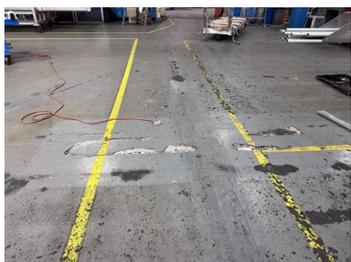
Designated walkway was heavily damaged over the years.

Traditional concrete was unable to withstand the chemicals and heavy traffic.

Area to be repaired

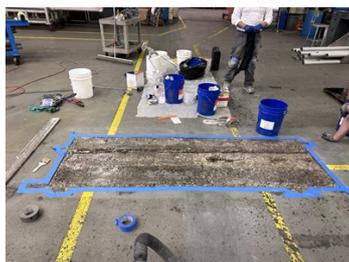
Repair area defined, sawcut and excavated
4911 Surface Conditioner Applied

Area was sawcut to a minimum of 0.25". Low spots were up to 3" deep and exposed rebar was prepped using a Bristle Blaster. A chipping hammer was used to remove break up the sections that were well adhered.

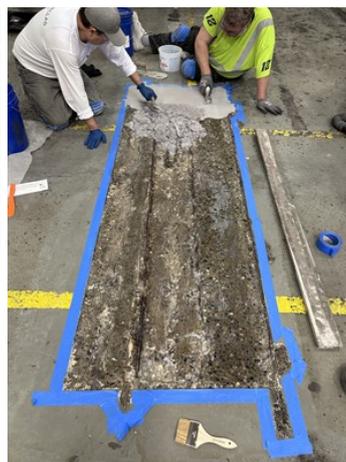
4111 Being Applied

Customer needed a quick turnaround to accommodate the next days shift. The floor was suffering from daily chemical contact that had worked through the previous coating and into the concrete. 4111 was selected for the quick turnaround and chemical resistance. The repair was completed with four and a half kits of 4111 in 3 hrs. No delays for the next days production.

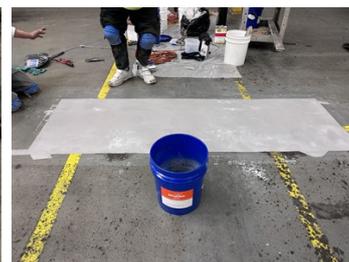
Finished Application
