Emergency Floor Repair with Belzona 4111

ID: 9031

Industry:	General Industry	Customer Location:	Kirkland Washington
Application:	FPA-Floor Problem Areas	Application Date:	March 2023
Substrate:	Concrete		
Products:	Belzona 4111 (Magma-Quartz),Belzona 4911 (Magma TX Conditioner)

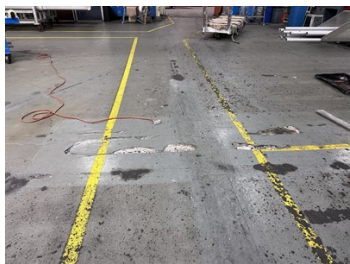
Designated walkway was heavily damaged over the years.
Previous repairs had failed and the client was faced with safety violations.
Traditional concrete was unable to withstand the chemicals and heavy traffic.

Area to be repaired

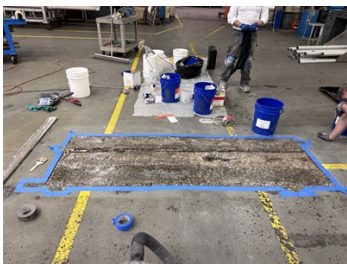
Repair area defined, sawcut and excavated
4911 Surface Conditioner Applied

Area was sawcut to a minimum of 0.25". Low spots were up to 3" deep and exposed rebar was prepped using a Bristle Blaster. A chipping hammer was used to remove break up the sections that were well adhered.

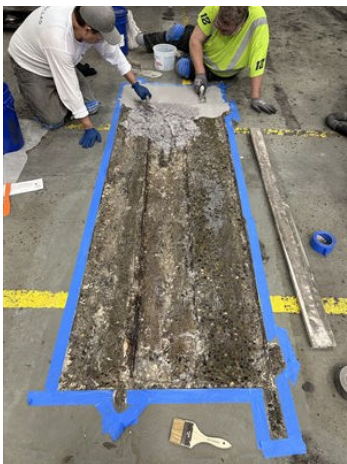
4111 Being Applied

Customer needed a quick turnaround to accommodate the next days shift. The floor was suffering from daily chemical contact that had worked through the previous coating and into the concrete. 4111 was selected for the quick turnaround and chemical resistance. The repair was completed with four and a half kits of 4111 in 3 hrs. No delays for the next days production.

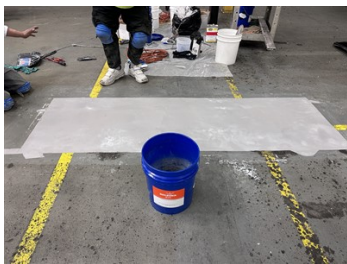
Finished Application
