# Fractured GRP pipe repaired with Belzona Super Wrap 2

ID: 9033

Industry: Power  
Application: VPF-Valves, Pipes and Fittings  
Substrate: GFRP  
Products: Belzona 1212, Belzona 1983 (SuperWrap II)

Customer Location: Ireland  
Application Date: March 2023

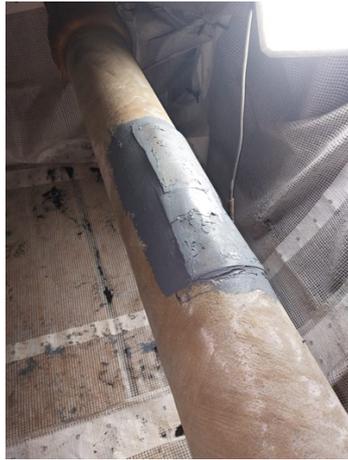
Fractured 8" GRP pipe

Steel plate bonded over the hole with Belzona 1212

The GRP was cleaned by grit blasting and a steel plate was bonded over the hole to act as a support for the reinforcing wrap

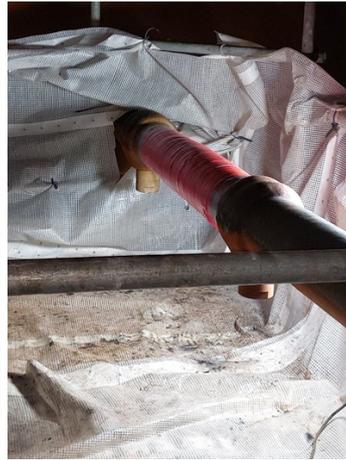
Damaged area reinforced using Belzona Super Wrap 2

Carrying out the repair allowed the plant to resume production. Replacing the pipe was not possible within a reasonable time period
