# BELZONA® 5851 HELPS AVOIDS SHUT DOWN

Industry: Oil & Gas  
Application: VPF-Valves, Pipes and Fittings  
Substrate: Duplex  
Products: \* Belzona® 5851 (HA Barrier),

Customer Location: Production Rig North Sea  
Application Date: May 2007

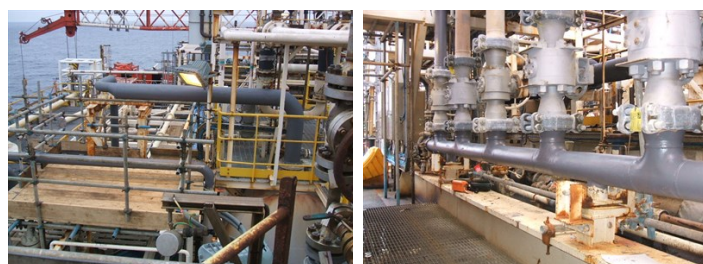
The loss of the original paint system exposed the pipe work to a risk of stress corrosion cracking whenever the fire protection Deluge system were tested.

- \* Manifold showing weathering of paintwork ,
- \* Belzona® 5851 applied to exposed pipe work ,
- \* Belzona® 5851 applied to exposed pipe work ,
- \* Belzona® 5851 applied to the manifold ,

Weathering of the original paint system on high temperature Duplex lines.

Application carried out in accordance with modified Belzona System Leaflet VPF-2. The pipe- work was wet-blasted to remove poorly adhering paintwork and any salts from the substrate.
