# Belzona quickly saves the ripped conveyor belt

ID: 9044

Industry: *Mining & Quarrying*  
Application: *SHM-Solids Handling Machinery*

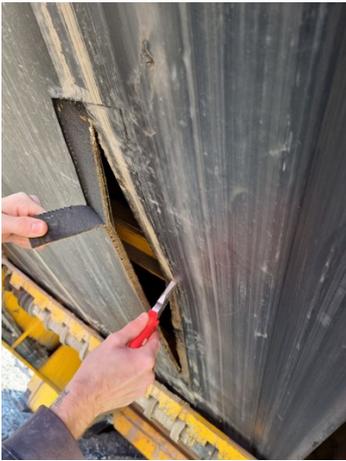
*An incident in production caused damage to a conveyor belt. The belt was ripped through the middle in length of more than 1 m. The production had to stop.*

Ripped conveyor belt

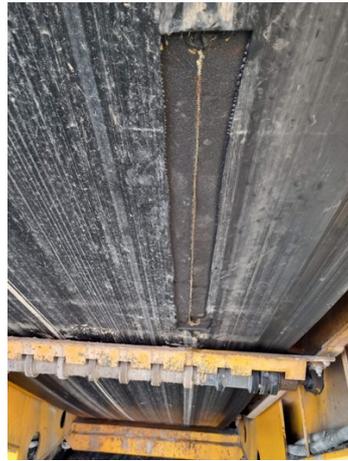
First layer of the belt peeled off in order to install belt fasteners properly

First we peeled off (delaminated) the first layer of the belt in order to install belt fasteners in the way then aren't above the belt level. Then we installed belt fasteners, abraded them with the grinder and applied Belzona 2911 and Belzona 2311.

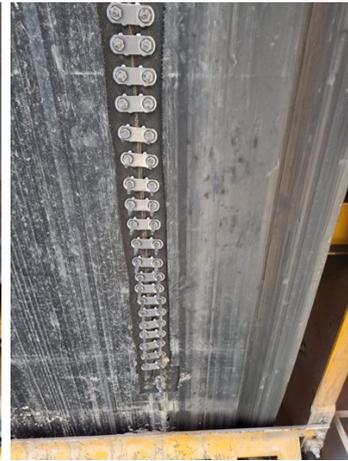
Belt fasteners installed

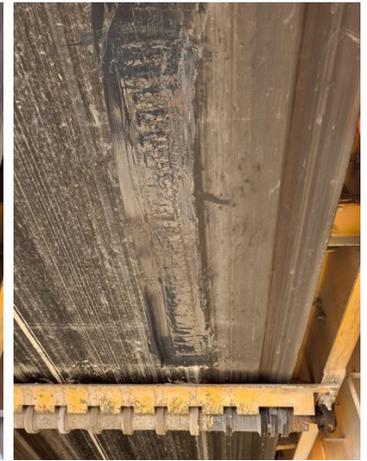
Belt fasteners protected with Belzona 2311
