Belzona 4311 CR1 protects bunds from chemical attack

ID: 9045

Industry: *General Industry*
Application: *TCC-Tanks and Chemical Containment Areas*
Substrate: *Concrete*
Products: *Belzona 4311 (Magma CR1), Belzona 4911 (Magma TX Conditioner)*

Customer Location: *Scotland*
Application Date: *April 2023*

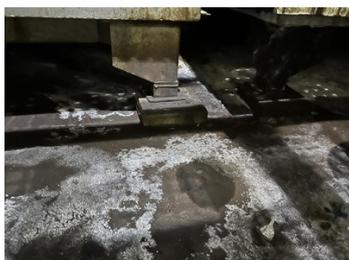
Confined access under the vats

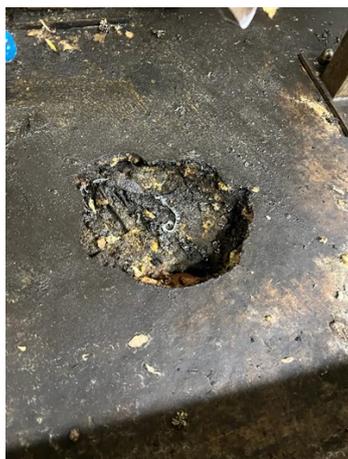
Several concrete bunds had been corroded by the aggressive chemicals used in the production process. A chemical resistant system was required to provide protection against the strong inorganic acids & alkalis used in the area.

Deep corrosion in areas of spillage

The bunds were power washed to remove any chemical contamination. They were then abraded, Belzona 4911 TX Conditioner applied followed by two coats of Belzona 4311 CR1

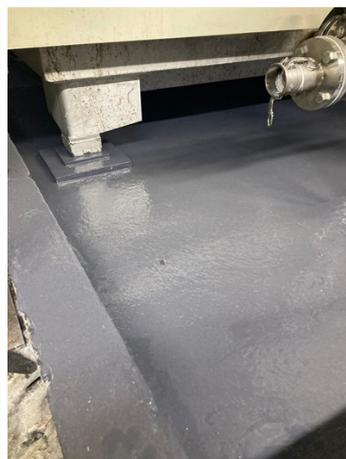
Belzona 4311 applied

The systems were applied by brush to the required thickness. The metal vat legs were also coated to provide a seamless, leak free system

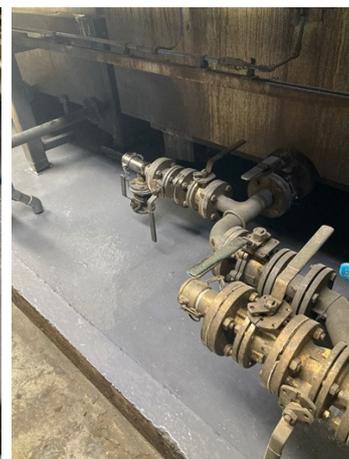
The system can be applied around complex geometry seamlessly
