# Belzona 4311 CR1 protects bunds from chemical attack

ID: 9045

Application: TCC-Tanks and Chemical Containment Areas

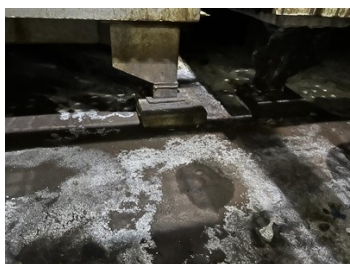
Confined access under the vats

By using a non solvented system minimised disruption to the plants process & allowed work in the confined spaces underneath the Vats. The fast cure time meant little downtime before the process in the area could be brought back into service.

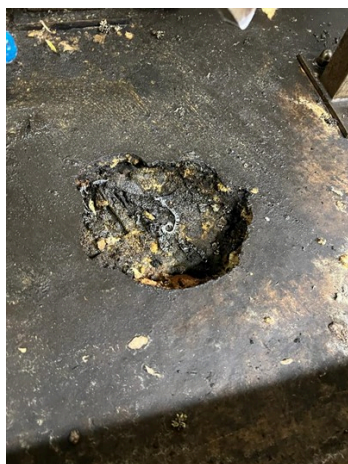
Several concrete bunds had been corroded by the aggressive chemicals used in the production process. A chemical resistant system was required to provide protection against the strong inorganic acids & alkalis used in the area.

Deep corrosion in areas of spillage

The bunds were power washed to remove any chemical contamination. They were then abraded, Belzona 4911 TX Conditioner applied followed by two coats of Belzona 4311 CR1

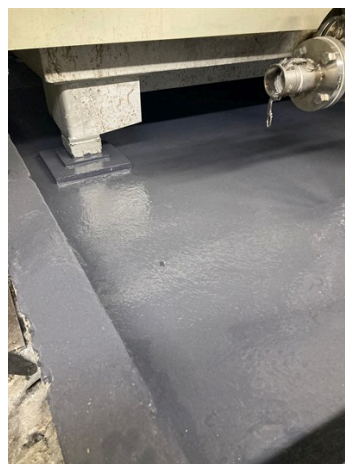
Belzona 4311 applied

The systems were applied by brush to the required thickness. The metal vat legs were also coated to provide a seamless, leak free system

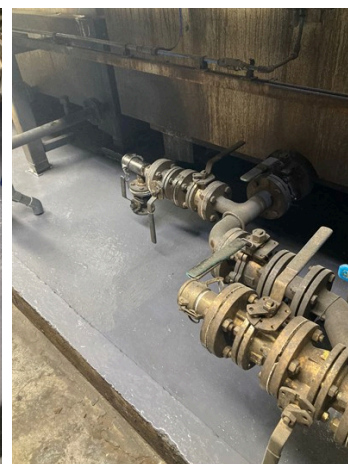
The system can be applied around complex geometry seamlessly
